A site history & field guide for

# **Ecological Mangrove Rehabilitation in Tiwoho Village, Bunaken National Marine Park, North Sulawesi, Indonesia**

Ben Brown  
Rignolda Djamaluddin

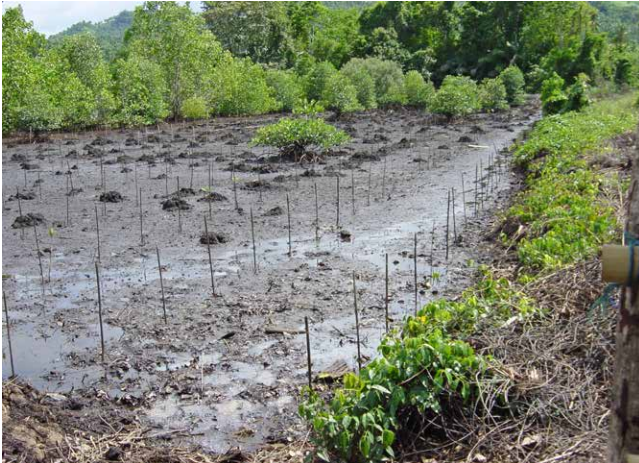
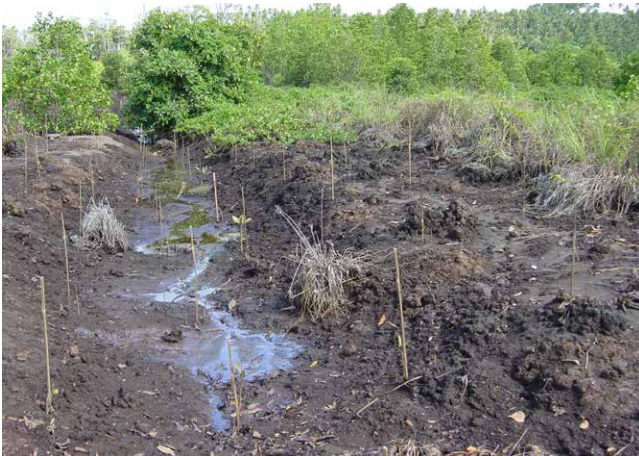
Photos: Ben Brown

Transects of the area were undertaken as part of a pre-restoration assessment in 2001, showing significant natural revegetation in the seaward five ponds, and near zero grow-back in the landward set of ponds, as well as all other cleared sections.

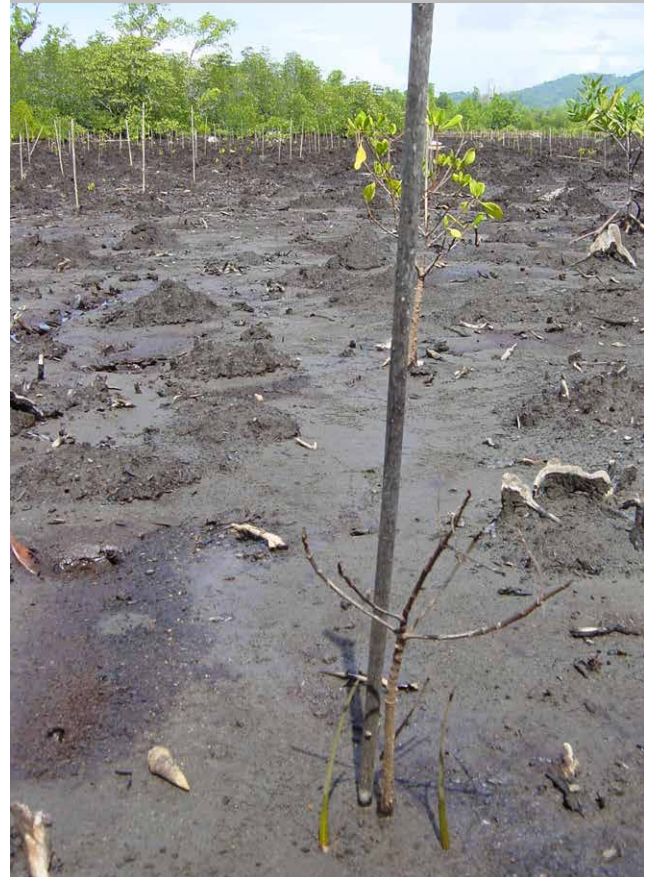
Unvegetated areas were planted a total of seven times during the period 1995–2004. These planting events were facilitated by various agencies in the Forestry Department, and undertaken by a small subset of paid local community members (usually around eight individuals) all family members of the long-term village head. Only cuttings of the Rhizophoraceae family (mostly *Ceriops tagal*, and all three local *Rhizophora* spp.) were planted. The initial six plantings experienced near total mortality. The seventh planting, which took place 2 months prior to hydrological rehabilitation in 2003, resulted in some survivorship, which appears today as neat rows of *Ceriops tagal* in an area that still has hydrological drainage issues.

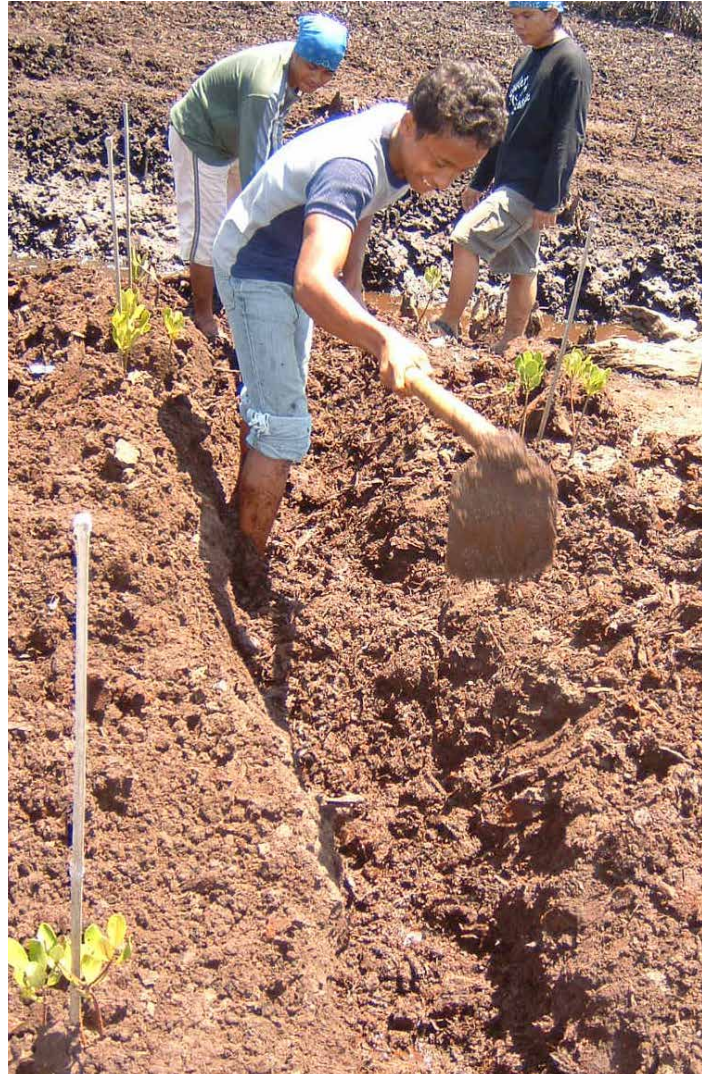
During this project, strategic breaching of dike walls, filling of artificial channels and creation of small tidal channels were undertaken by the local community with the use of hand tools. Hydrological restoration began in October, 2003, which is considered time zero for this project.

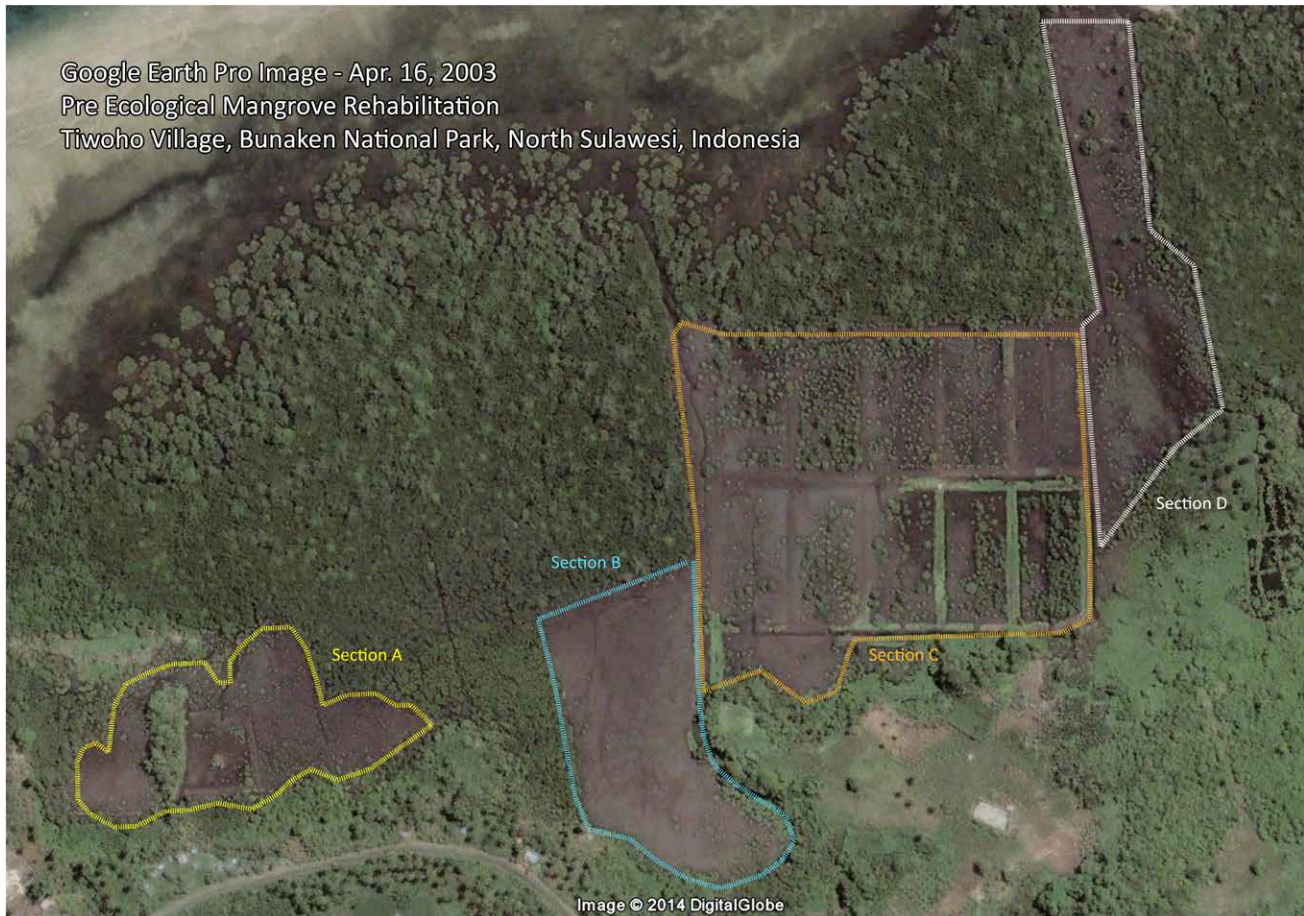
2003 – Pre-rehabilitation.

The following slides will depict the development of the site – both from long-term photo stations and through available Google Earth imagery.

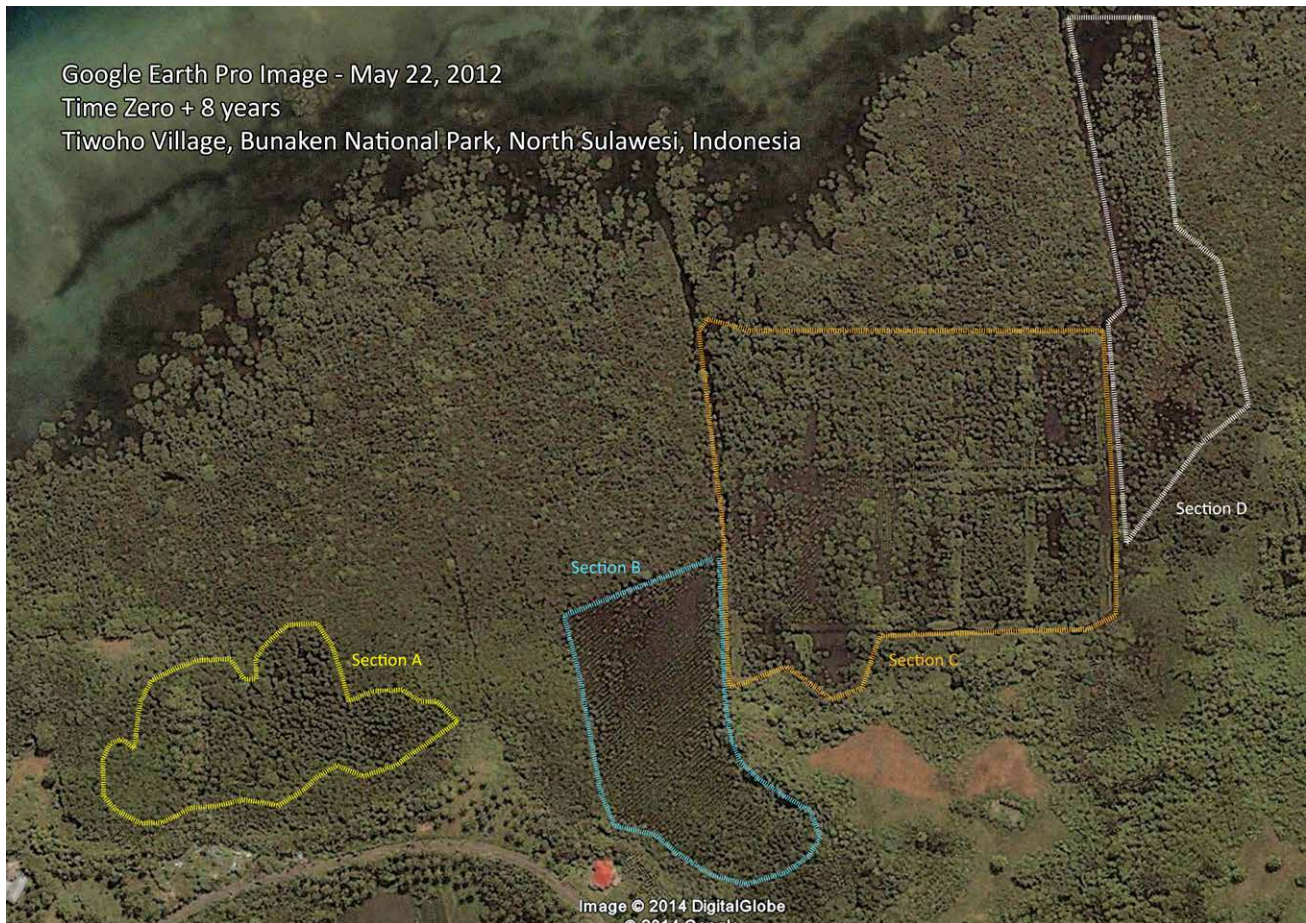
2012 – Time Zero + 8 years.

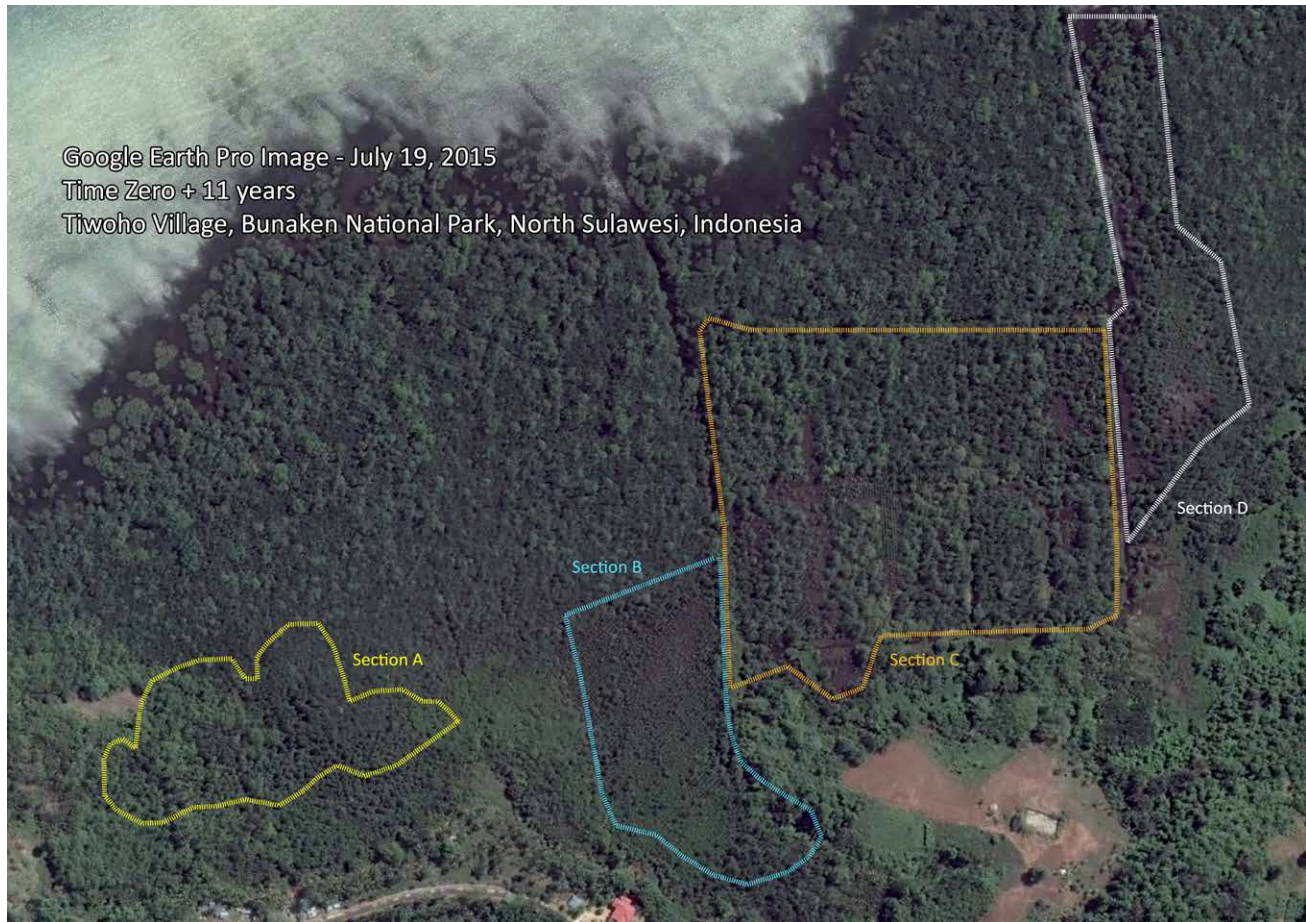
2015 – Time Zero + 11 years.

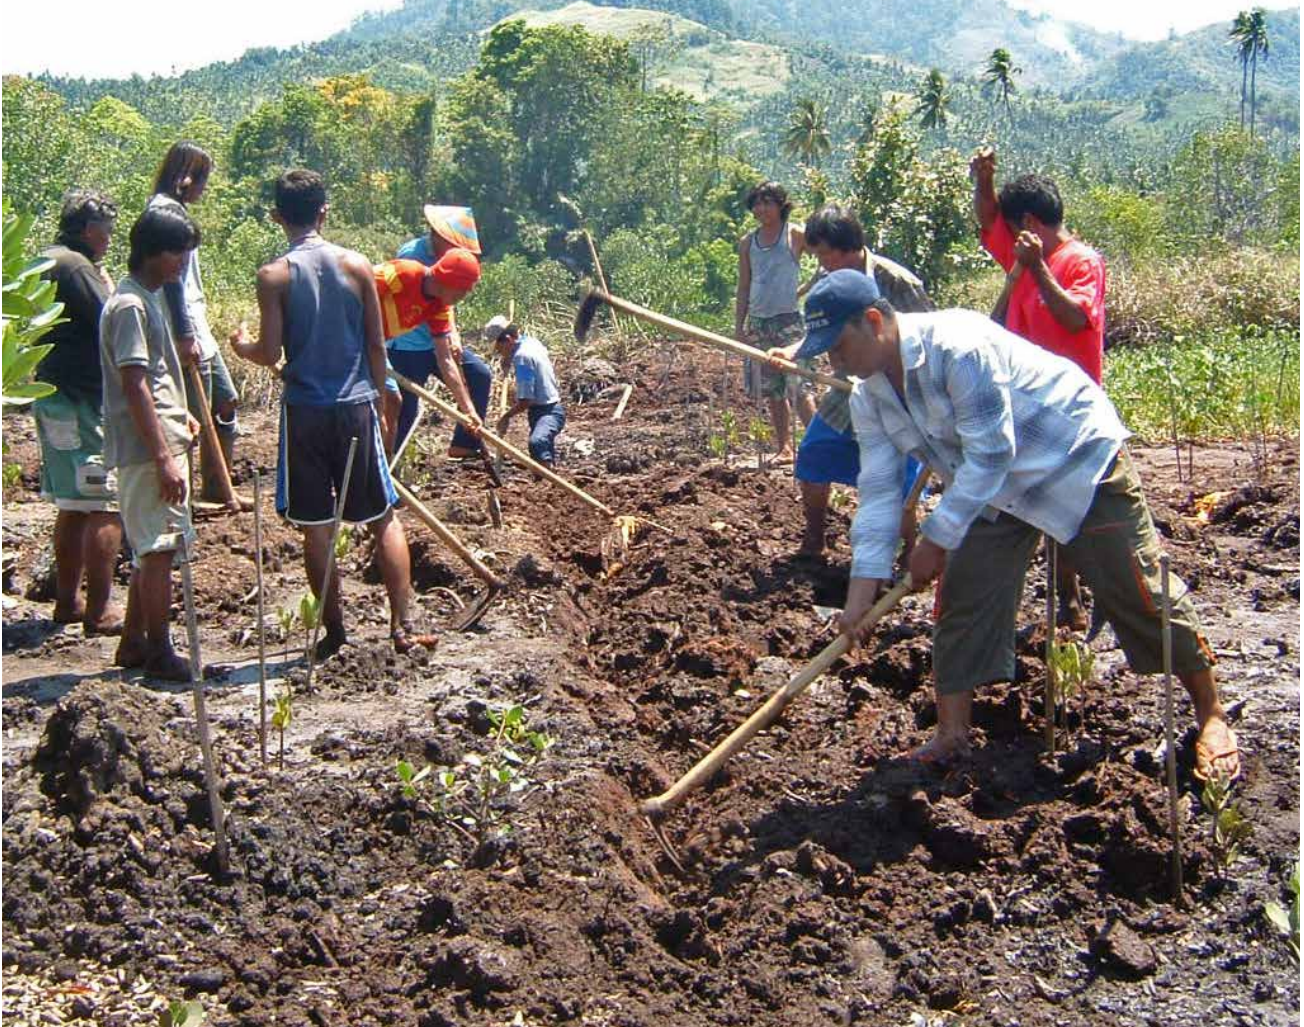
Photo: Rignolda DjamaLuddin

Time Zero (October, 2003).

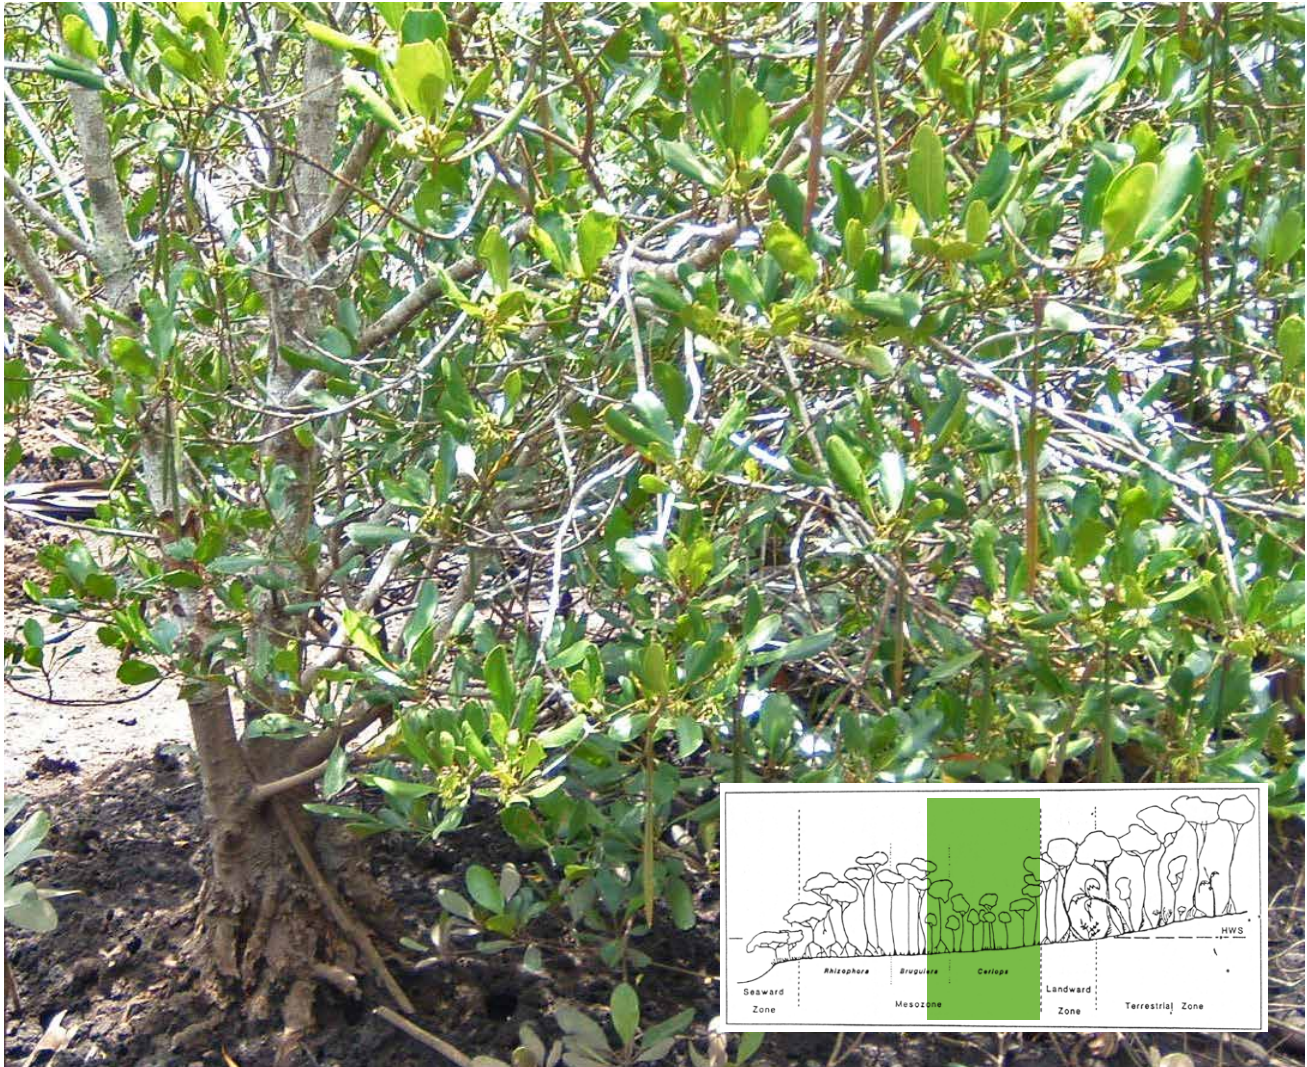
Photo: Ben Brown

*Ceriops tagal* is abundant in the transition zone between upper and mid-mangrove zones, and is especially adapted to colonize hypersaline substrate. Numerous *C. tagal* were planted by the government immediately prior to hydrological rehabilitation, and survive in straight rows. Thinning of these stands, and mid-course corrections to continue to improve hydrological functioning is a recommended follow-up action.

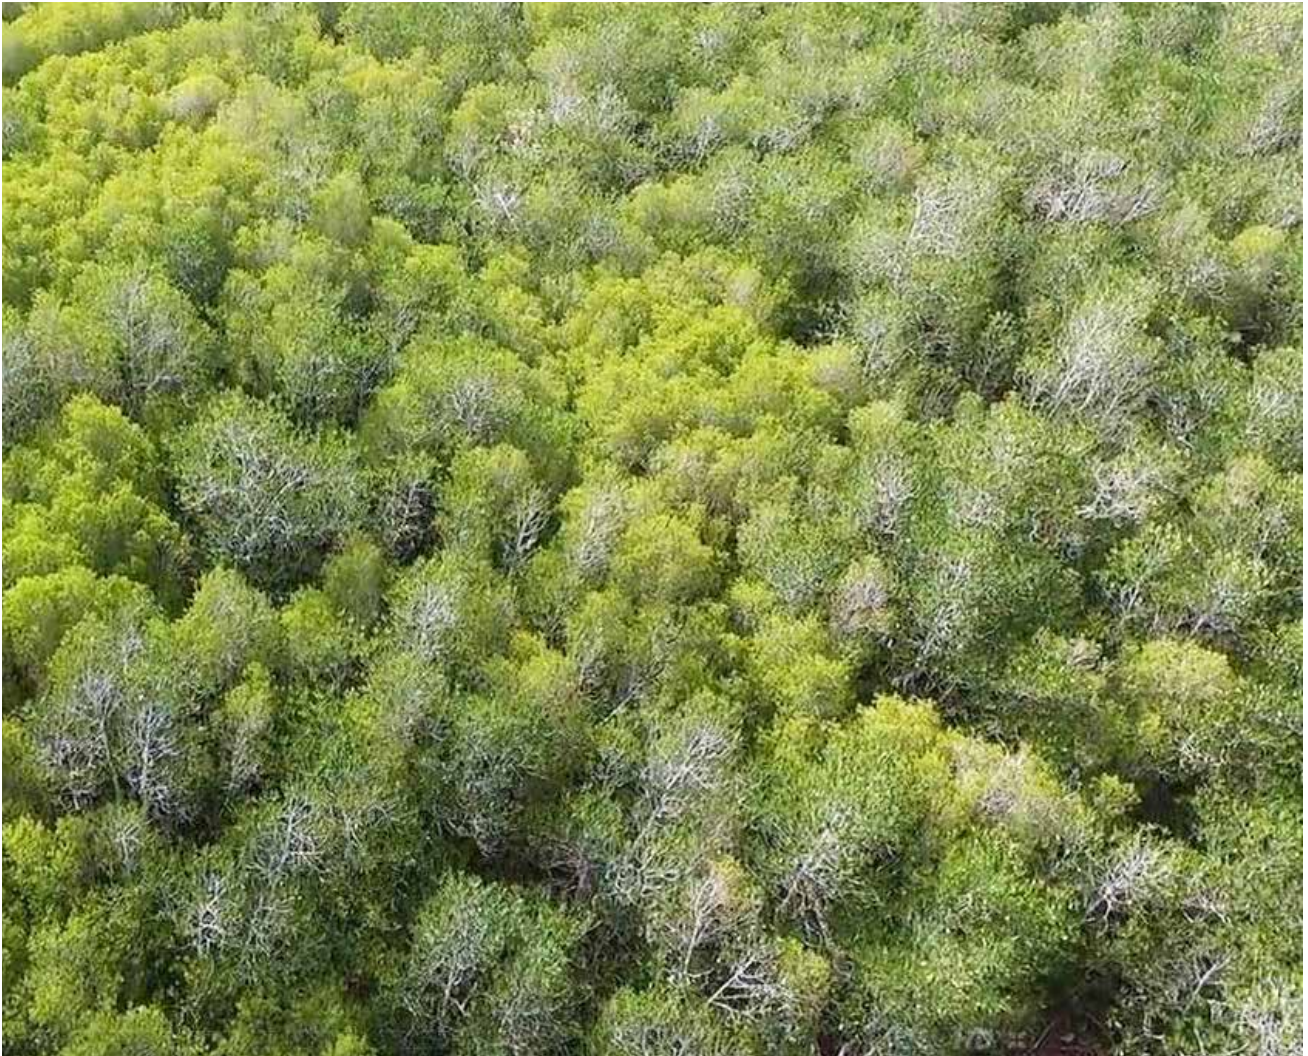
Photo: Aaron Burton

Images from a 2016 aerial (Phantom 3 drone) survey reveal mangrove stress and die-off of mature trees. Although natural thinning is expected in this forest, mid-course corrections in the form of hydrological enhancement are likely required at the site to facilitate drainage and reduce instances of water logging. Placement of water-level loggers will be required to more accurately determine areas of waterlog stress.
